**Technical Report**  
**Flooding in the Great Bay Area, South St. Elizabeth in**  
**Association with Hurricane Emily, July 15 – 16, 2005**

**Water Resources Authority**  
**Hope Gardens**  
**PO BOX 91**  
**Kingston 7**

**Water Resources Authority**  
**August 28, 2005**

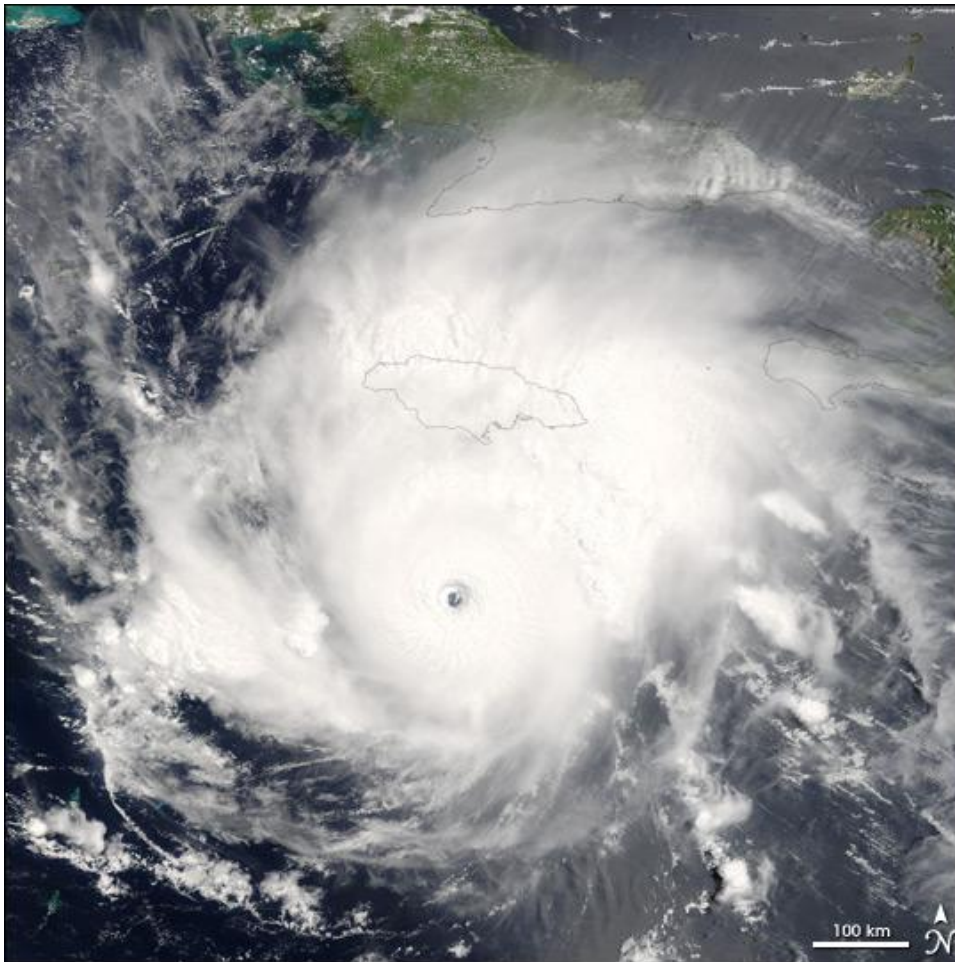
Figure 1: Hurricane Emily's Closest Position to Jamaica (source: [www.earthobservatory.nasa.com](http://www.earthobservatory.nasa.com))

Emily is responsible for five deaths through the Caribbean, as well as considerable damage in places as far apart as the Lesser Antilles Islands and Jamaica to Mexico's Yucatan Peninsula. (source: [www. Earthobservatory.nasa.org](http://www.Earthobservatory.nasa.org)) The hurricane's eye was closest to the island of Jamaica at 4 pm on the 16<sup>th</sup> of August when it was about 90-100 miles or 140-150 kilometres southwest of Luana Point in south southwestern St. Elizabeth with highest sustained winds at near 250 kilometres per hour (Figure 1). (source: MetService)

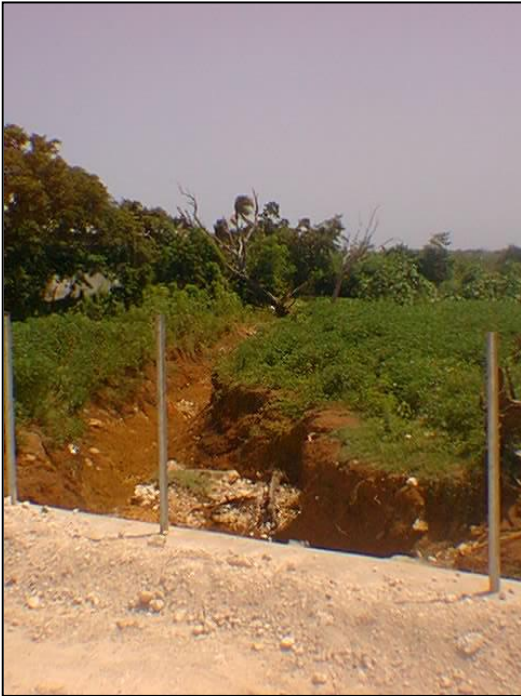
Photo 1  
Natural drain along the Flagaman to Treasure Beach road viewing towards Great Bay.

Damage is mainly associated with erosion of road surfaces and break aways of concrete gully structures. The road leading from Flagaman to Treasure Beach intersection and then further southward towards the Treasure Beach community has experienced significant erosion particularly along the sides of the road. (see Map 1) The U-drain leading from the Pedro Plains police station towards Great Bay shows heavy silting with marl (possibly from road base) and limestone fragments (possibly from the outcropping limestone rock). The aforementioned U-drain follows the road for approximately 450 m before making a 90° turn to allow water to underpass the road. This sharp turn causes deposition of debris which blocked the drain and caused an overflow. Natural gullies cut through the hinterland and have caused some minor damage along property walls (Mr. Winston Smith's property). Damage to houses could not be ascertained but particularly at the southern and western edge of the Great Pedro Pond two housing units appear to be the ones most affected as water has entered the units. Across the Sandy Bank road a smaller pond fills frequently after heavy rain. There was no damage to houses but large tracts of residential lots were under water. According to residents this pond overflows the Sandy Bank road near the newly constructed Treasure Beach Shopping complex and flows towards the Great Pedro Pond.

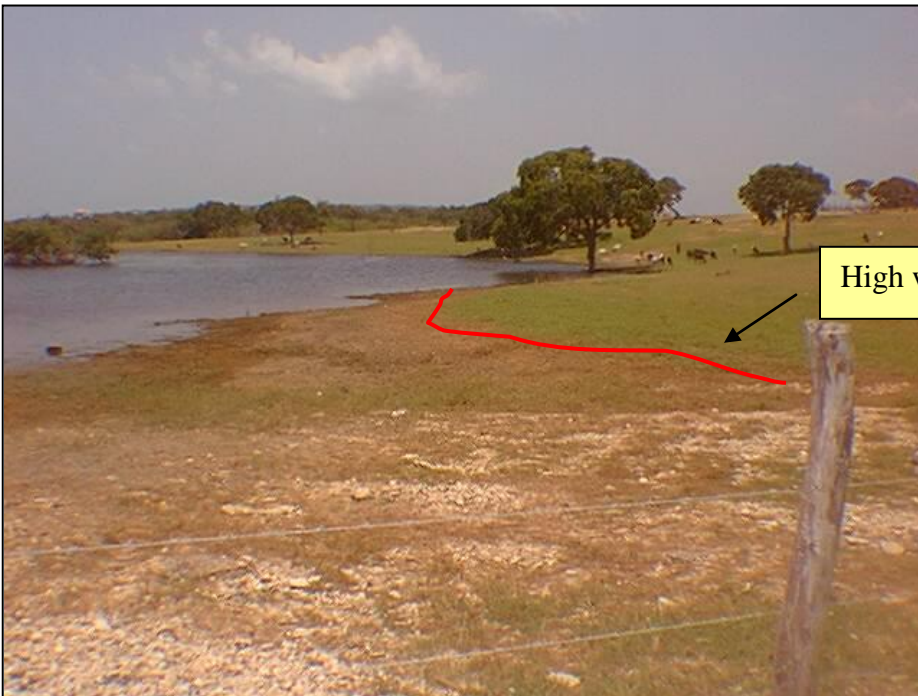
Photo 2  
Northern edge of Great Pedro Pond at Pedro Plain Police Station to Great Bay road in the vicinity of Mr. Winston Smith's property. Note the burnt grass indicating high water mark and bright spot in foreground indicating flow path.

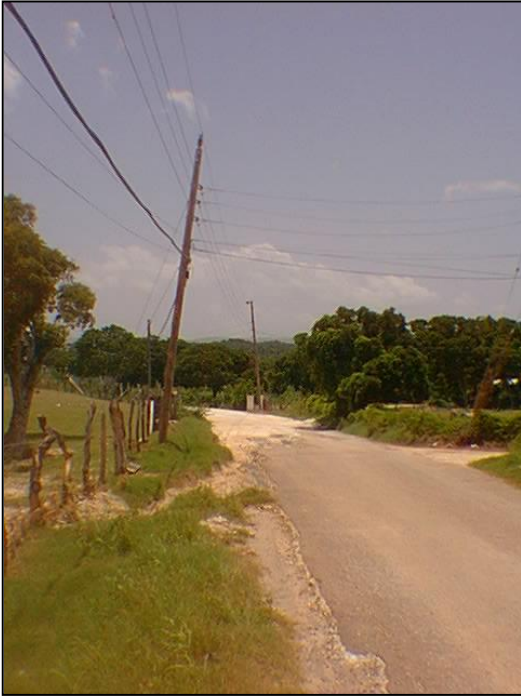
Photo 3

Image shows section where surface runoff crosses Great Bay parochial road in the vicinity of Mr. Winston Smith's property.

1. Individual home owners need to flood proof housing units. This can be done by raising the floor level and the roof.
2. The drains along the parochial roads to be reconstructed to allow for a controlled runoff.
3. Interceptor drains are to be constructed at locations where runoff crosses parochial roads.
4. The angle where the U-drain joins the culvert below Pedro Plains Police Station needs to be changed to reduce blockage and erosion.
5. It is recommended to use the 6 m contour line derived from the digital surface model created from the IKONOS image and representing the high water mark associated with flooding caused by Hurricane Charley, as the boundary below which no new housing units should be erected

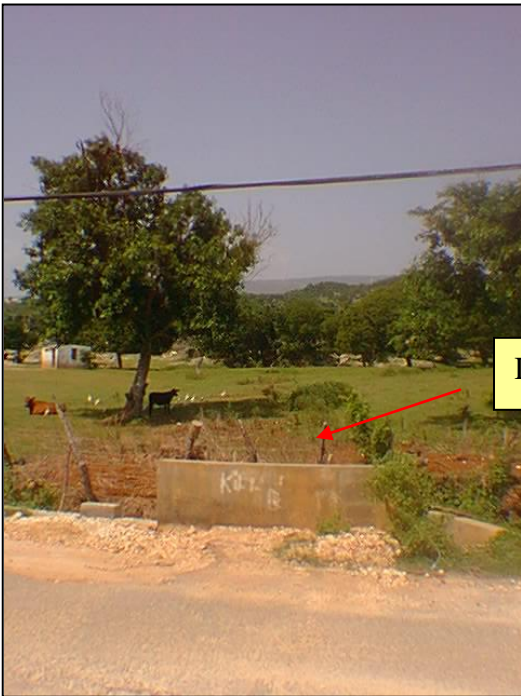
Photo 4

Location where U-drain which carries runoff coming from the Pedro Plains Police Station ends and discharges into a culvert. Note deposition of material within the pasture caused by backwater.

Deposited material

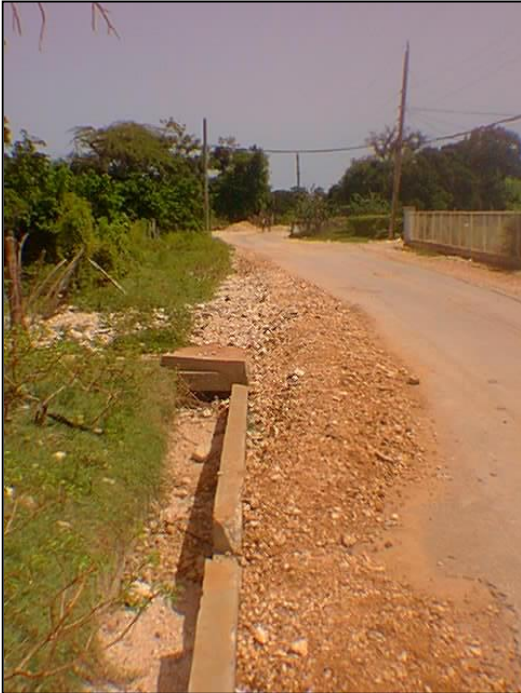
Photo 5  
U-drain blocked with marl preventing free conveyance along Great Bay parochial road

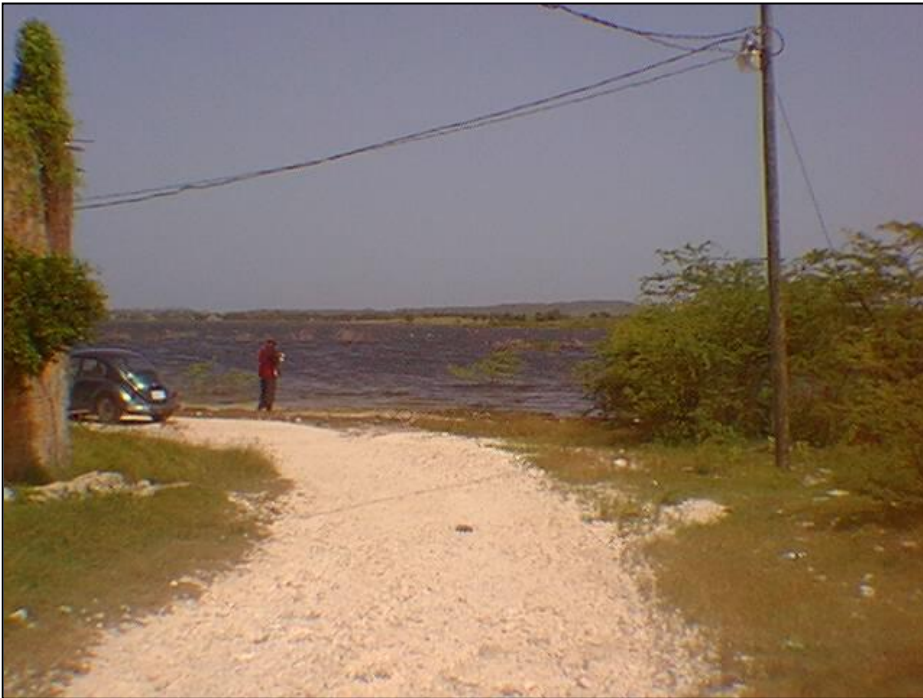
Photo 6  
View towards the Great Pedro Pond from Sandy Bank Road in the vicinity of Treasure Beach Shopping Complex

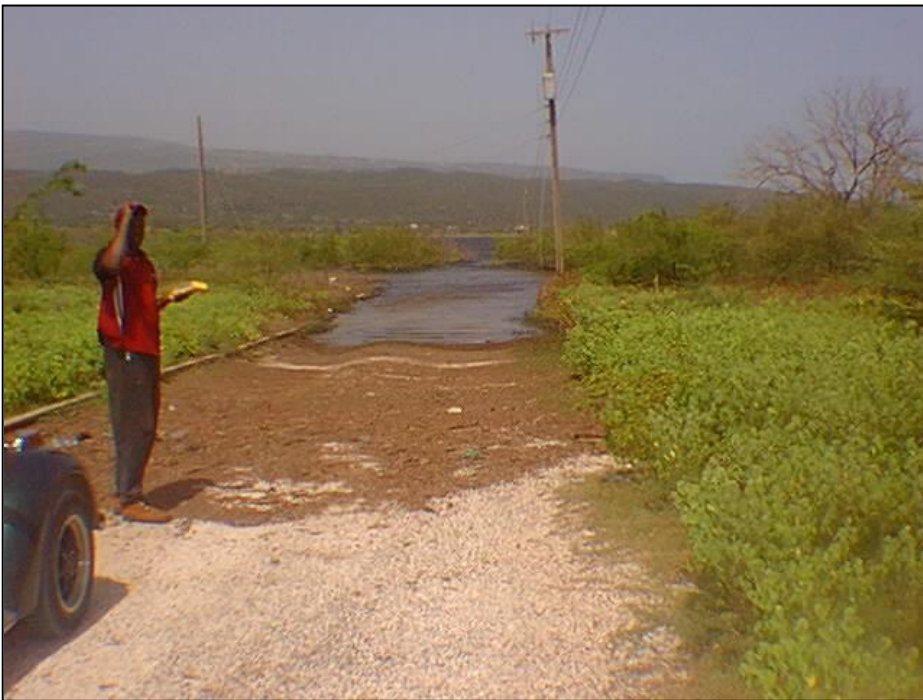
Photo 7

Extent of flooding along the southern end of the Pond within the newly subdivided section east of Treasure Beach

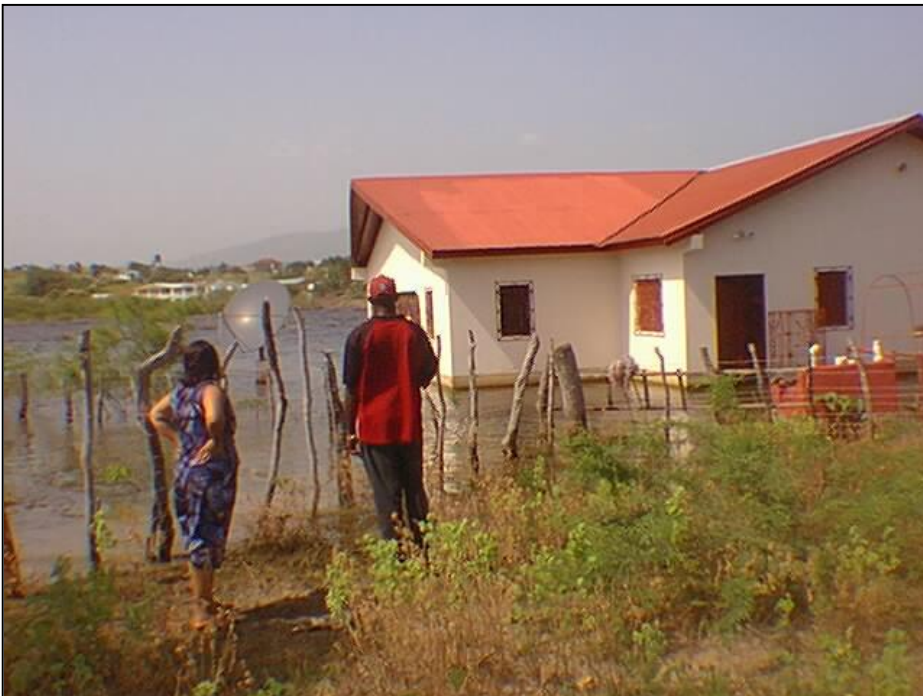
Photo 8

Temporarily abandoned building at southwestern edge of pond. Note high water mark at walls. Treasure Beach Shopping complex in background.
