WATER RESOURCES AUTHORITY

FLOOD REPORT

AUGUST TOWN GULLY

NOVEMBER 6, 1998

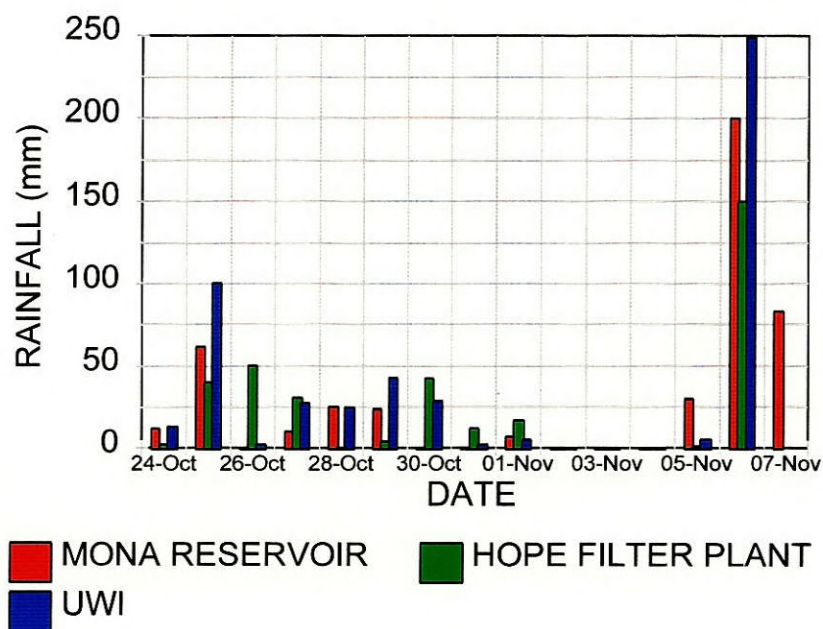
GRAPH 1
RAINFALL DATA - TWENTY FOUR HOUR RAINFALL

Rainfall data was collected from the Physics Department of the University of the West Indies (Mona Campus) and the National Water Commission's Mona Reservoir and Hope Treatment Plant Rainfall Stations (Table 1). This data is shown plotted as Graph 1. Other data collected include the inflows and outflows of the Mona Reservoir (Table 3- Graph 3).

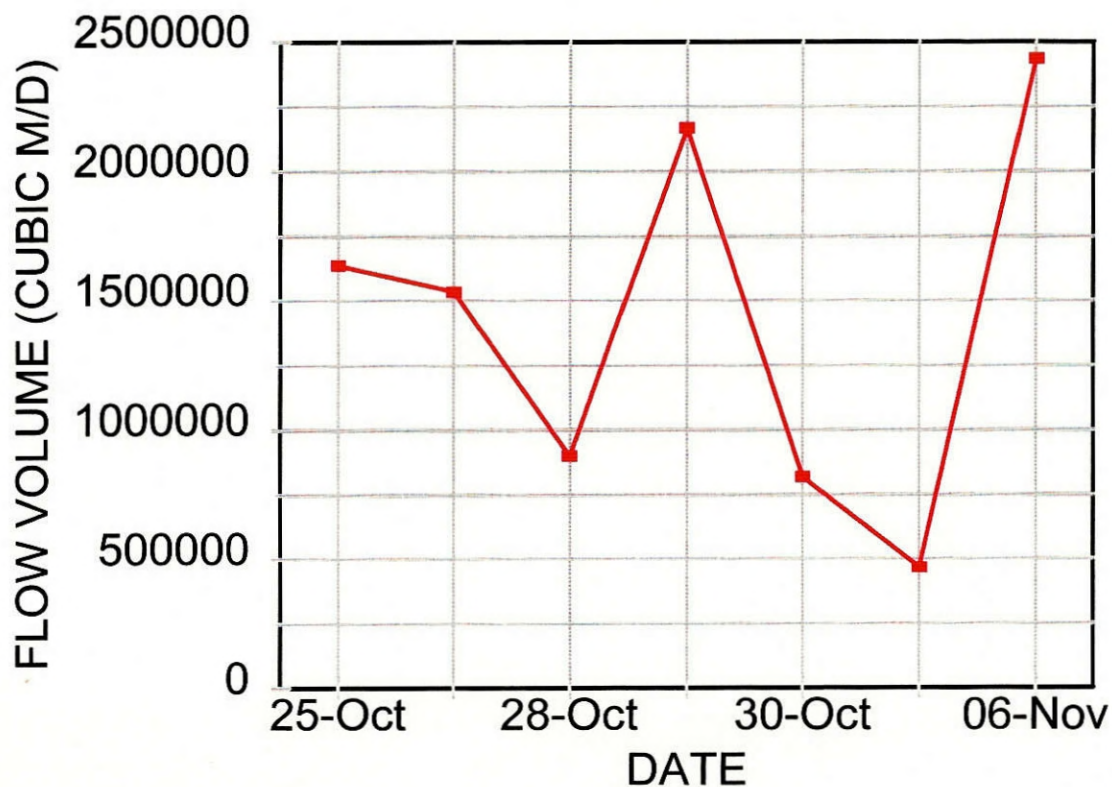
GRAPH 2**HOPE RIVER - PEAK FLOWS - OCTOBER 25 - NOVEMBER 6, 1998.**

The Water Resources Authority streamflow recording station on the Hope River at Grove recorded a rise in the river level of 1.2 metres in 1 hour between 2.00 a.m. and 3.00 a.m. on November 6, 1998 which suggest that the highest intensity of rainfall occurred during this period. Flows recorded during the rainy period October 24 to November 6 indicate that the peak flow in the Hope River was 34 cubic metres per second on November 6, 1998.. This flow has a return period of less than 2 years. (Table 2 - Graph 2). The high water mark of 1.07 metres, estimated from the height of debris deposited near the confluence with the August Town Gully (Plate 8), shows that the Hope River did not, at this flow, cause any backwater effect in the August Town Gully.

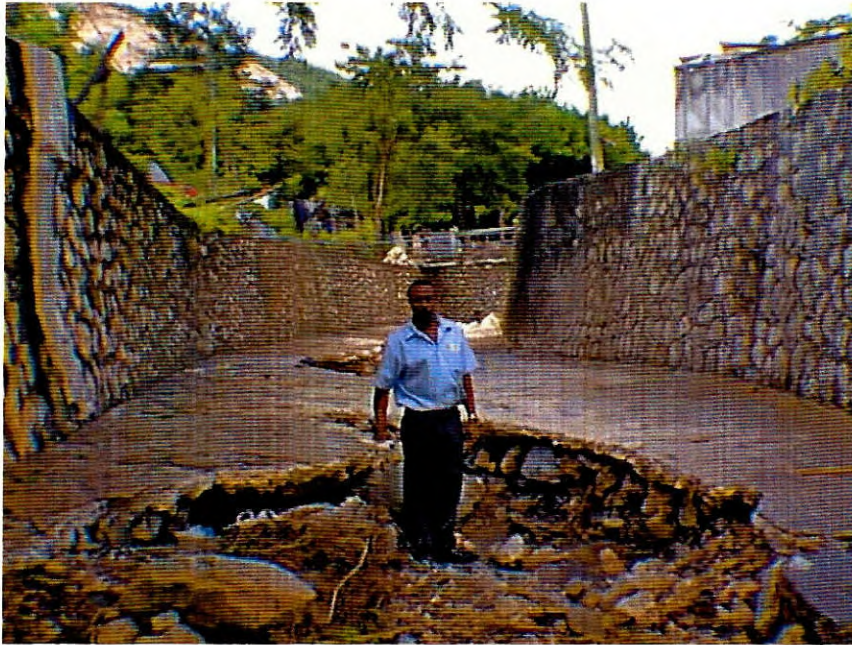
Plate 1. Scouring of concrete channel of Lower August Town Gully near confluence with Hope River (Section 1).

- Surface runoff from the Long Mountain and Beverly Hills region flows through a limestone quarry approximately 61 metres east and upgradient of the Mona Reservoir. This causes loose limestone material to be washed down from the quarry and deposited into the reservoir (Plates 10-12).
- As shown in Plates 1 - 7, the erosion of the gully channel and undermining of the foundation of the gully walls at several sections along the river gave rise to collapse of the wall at these locations. Residents confirmed that the walls were washed away or collapsed as a result of previous high volume surface runoff.
- There was evidence (springs in bottom of gully) of subsurface drainage in the August Town Gully on November 9, 1998. This could be due to overflow of storage from the August Town alluvial fill which was saturated by 2 weeks of rainfall.

- The main cause of the failure of the bank of the August Town Gully was the erosion of the lined channel and undercutting of the retaining wall over a period of several rainfall events.
- The lives of over 1,000 persons living in the flood way of the Hope River and August Town gully are at risk from future flood events. This is based on a preliminary count of houses and calculated at an estimated 5 persons per household.
- The August Town Gully drains the urban storm runoff from Mona, University of the West Indies, Hermitage and August Town area as well as the natural runoff from the Long Mountain and is likely to be backed up by the Hope River at its confluence causing inundation of houses in the lower August Town area.

- A programme of continuous repairs and maintenance of gully retaining walls and channels should be implemented in the August Town Gully and all other gullies draining urban runoff.
- Government should regulate against any further development and discourage squatting, on the Hope River Flood Plains within the August Town area.
- A public education and a flood awareness programme, including a community flood warning system, should be implemented in the Hope River Flood Plain between Grove and August Town.
- The Ministry of Works should carry out an investigation on the suitability of the existing type of gully construction in the August Town area based on the geology and soil type of the area.

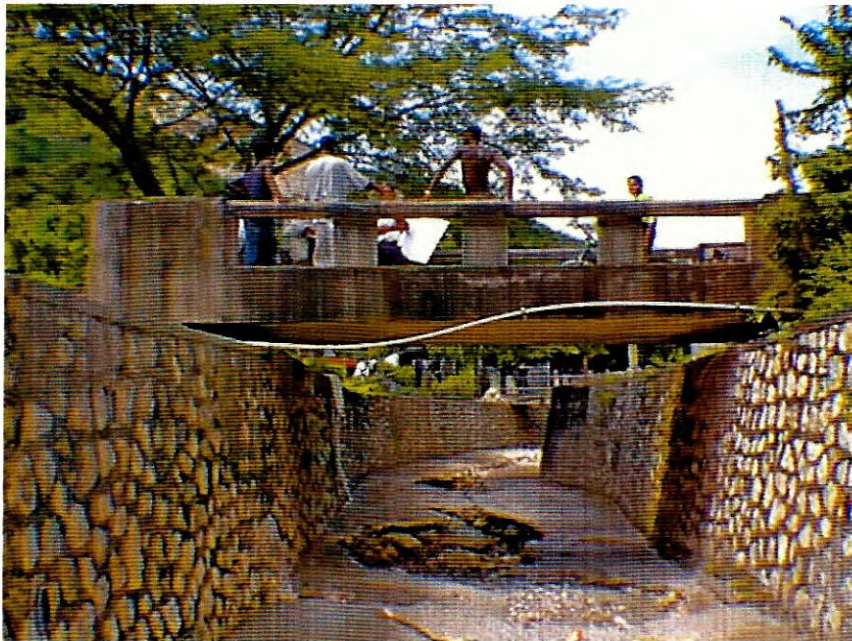
Plate 2. Bridge exposed to scouring of gully channel near confluence with Hope River.

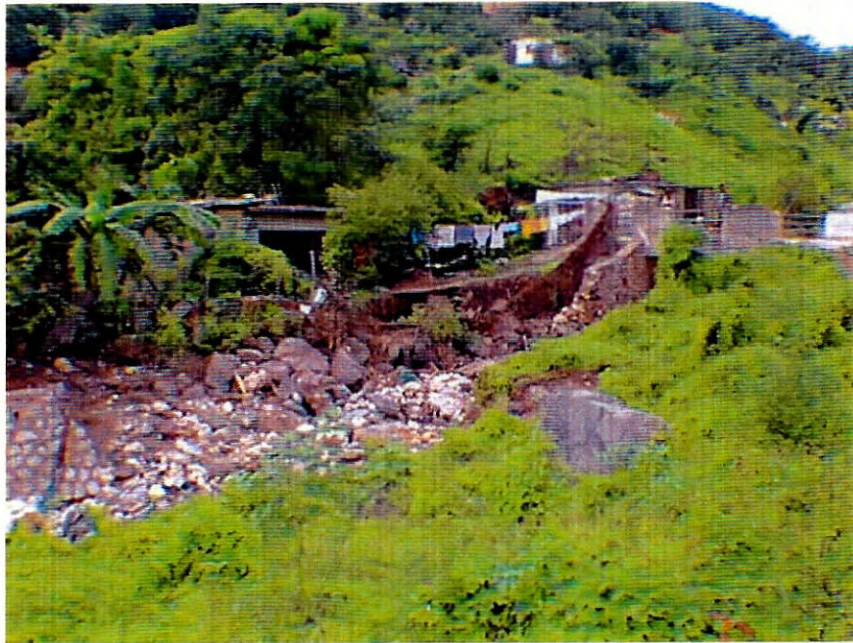
Plate 3. Upstream view of collapsed gully retaining wall (Section 2).

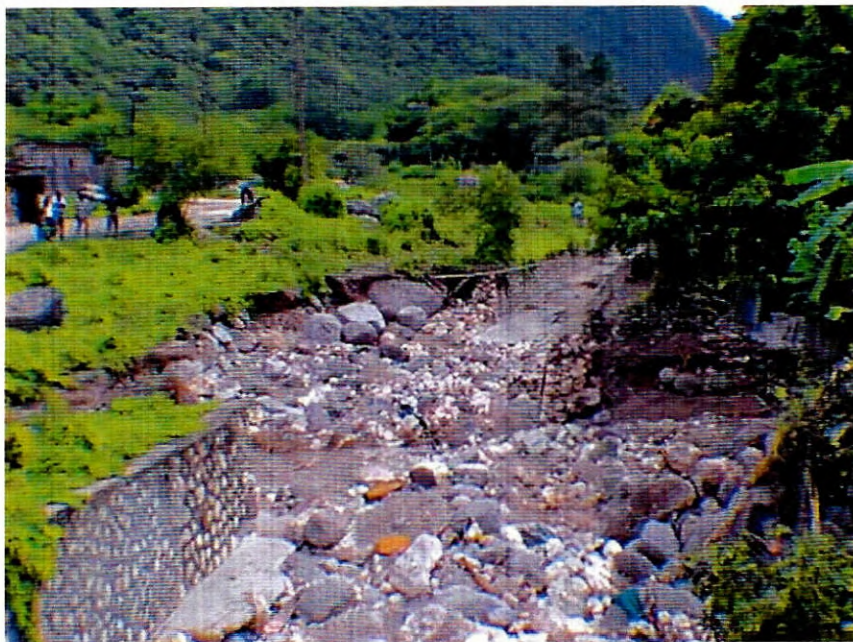
Plate 4. Downstream view of section of gully embankment that was damaged by flood water overflow.

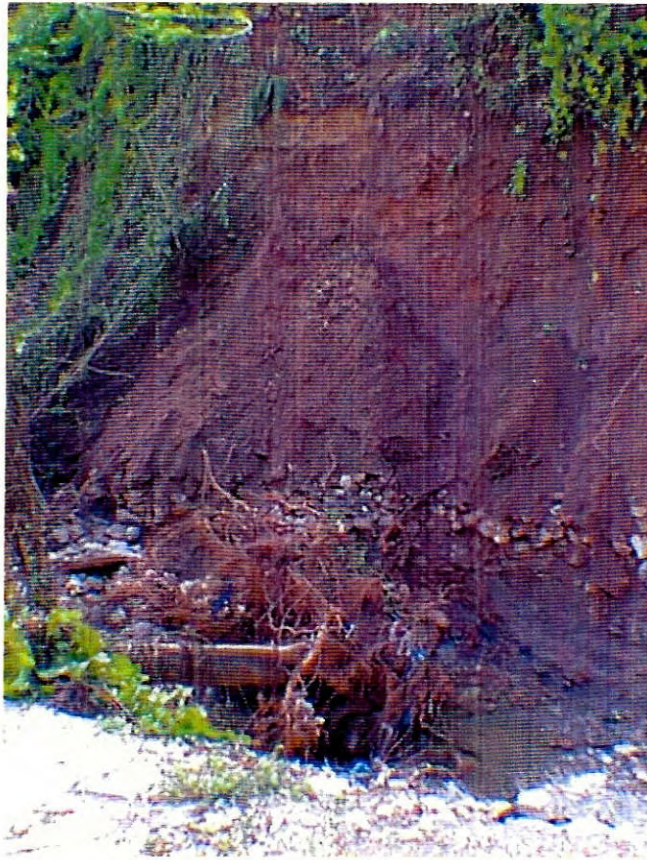
Plate 5. Gully bank slumping destroys retaining wall.

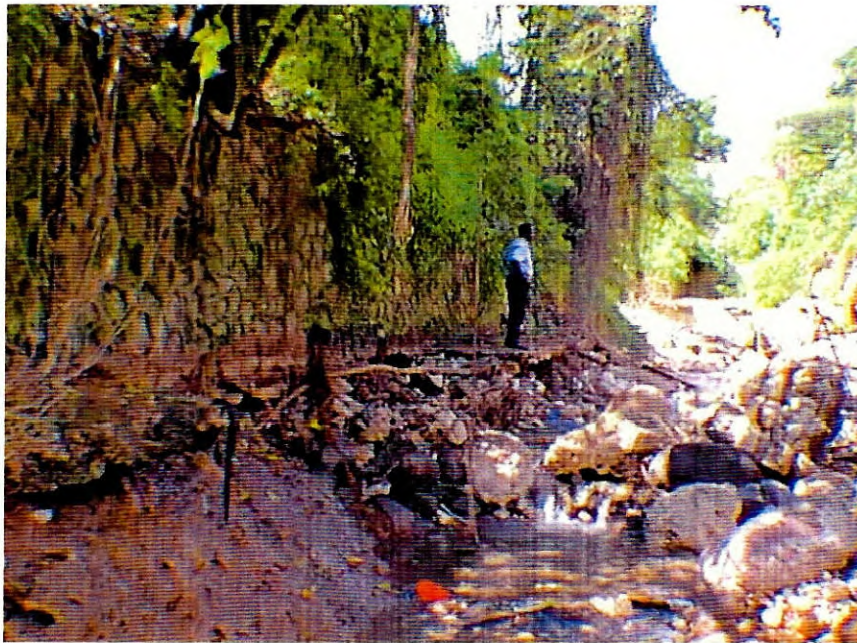
Plate 6. Undermined gully wall caused by erosion of the gully channel (Section 3).

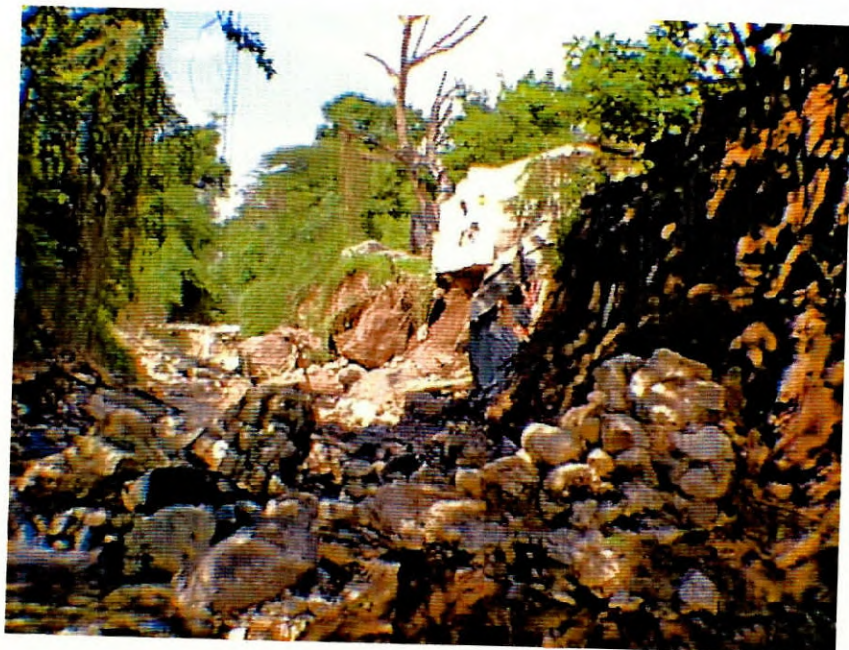
Plate 7. House from which two lives were lost by the gully flooding (6 November 1998). Notice exposed Gully embankment near house without retaining wall.

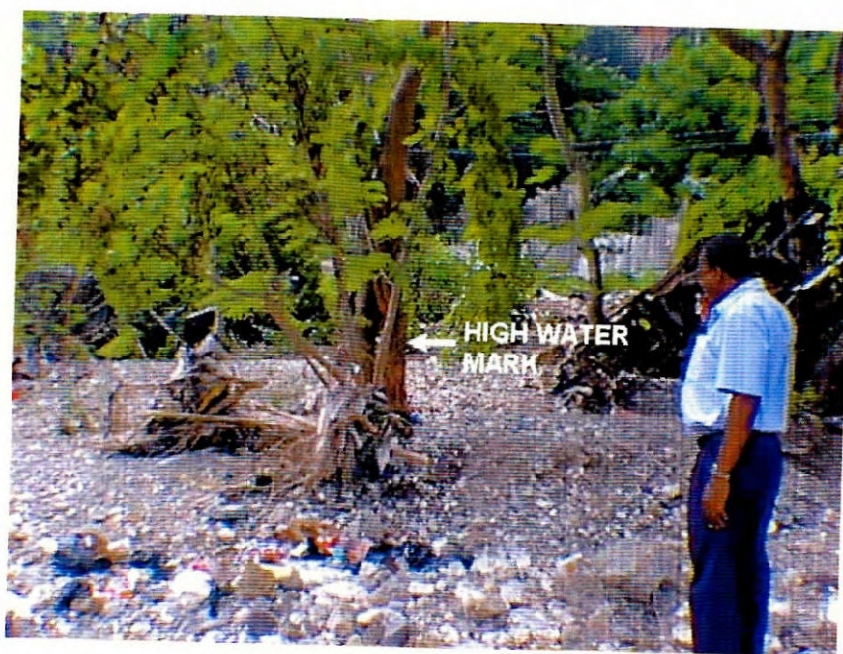
Plate 8. Debris showing flood levels of 3.5 feet on Hope River at August Town (9 November 1998).

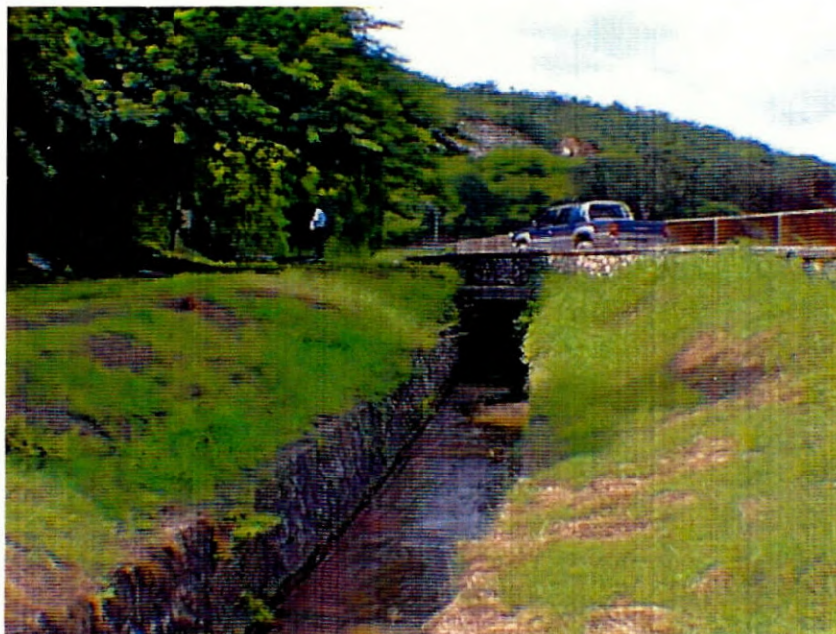
Plate 9. Mona Reservoir overflow canal (9 November 1998).

The Mona Reservoir has an overflow canal (Plate 9) which joins the August Town Gully at College Common near University of the West Indies. The overflow canal has a cross-sectional area near the reservoir of 3.35m^2 , and an estimated discharge capacity of approximately $8.49\text{ m}^3/\text{sec}$. (161.5 mgd.).

On November 6, the day of the flooding, records from the National Water Commission show that 18,176 cubic metres (4 million gallons) of water overflowed into the canal. This volume of water represents a very small outflow and did not contribute to the August Town Gully flooding as the estimated discharge capacity of the August Town gully in its lower reaches is approximately 25 times that of the Mona Reservoir overflow canal.

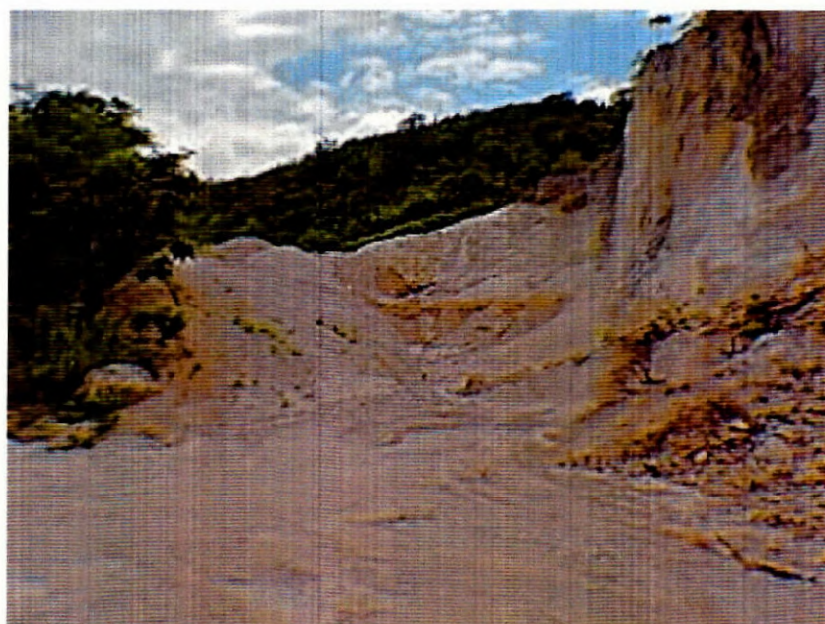
Plate 10. Limestone quarry located 200 feet above Mona reservoir causing debris flow into the Mona Reservoir.

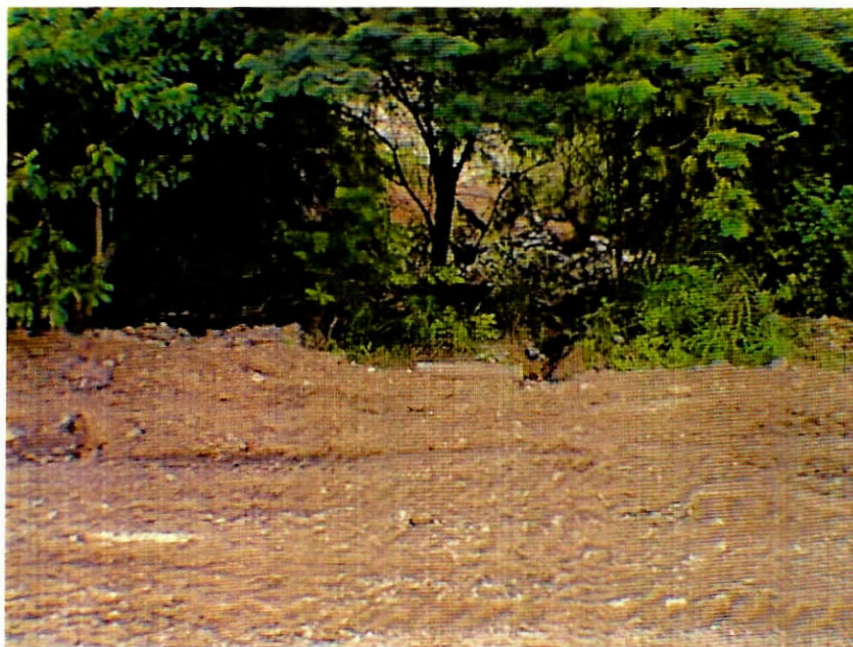
Plate 11. Loose limestone material (from existing quarry operations) some of which was deposited in the Mona Reservoir (9 November 1998).

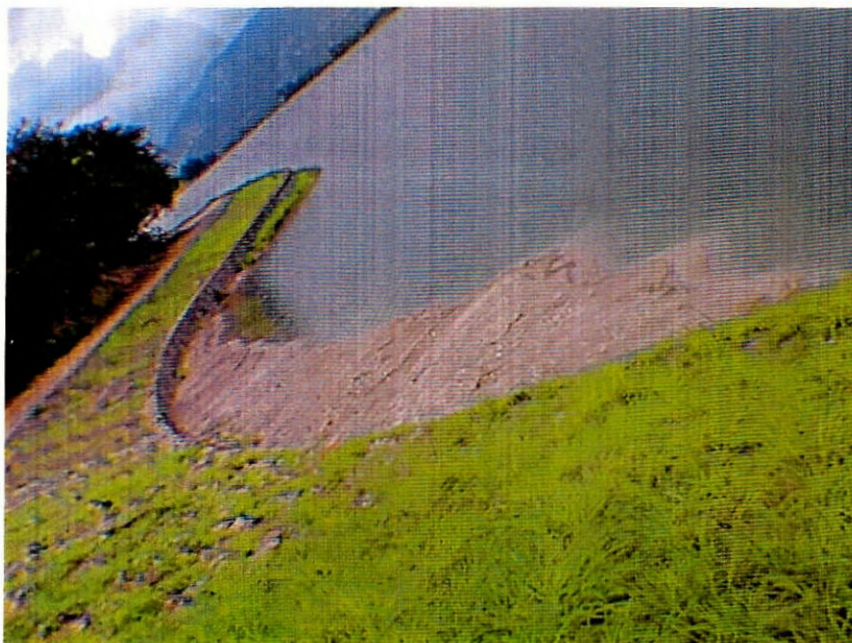
Plate 12. Quarried material deposited in the Mona Reservoir after heavy rainfall (6 November 1998).
