**Geological Society of Jamaica
March 11, 2006**

Flooding at Moneague

**Basil Fernandez
Managing Director**

Water Resources Authority

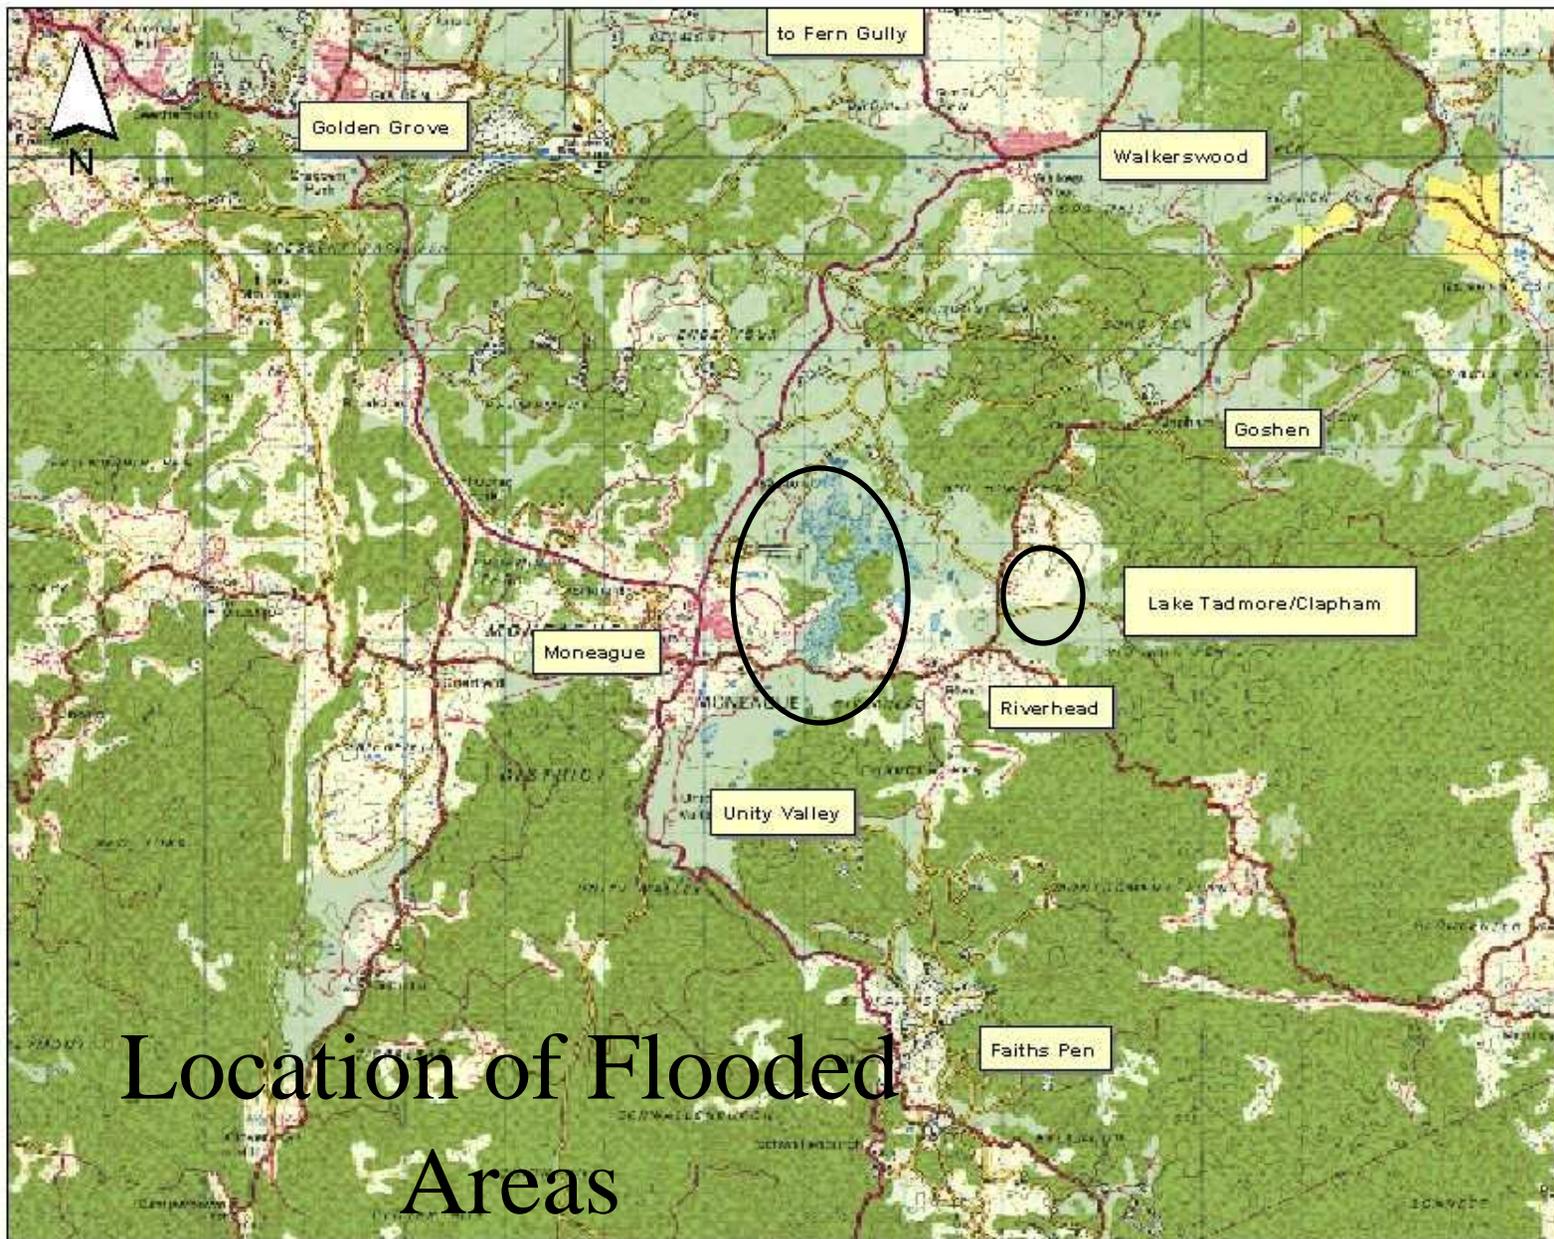
Location of Flooded Areas

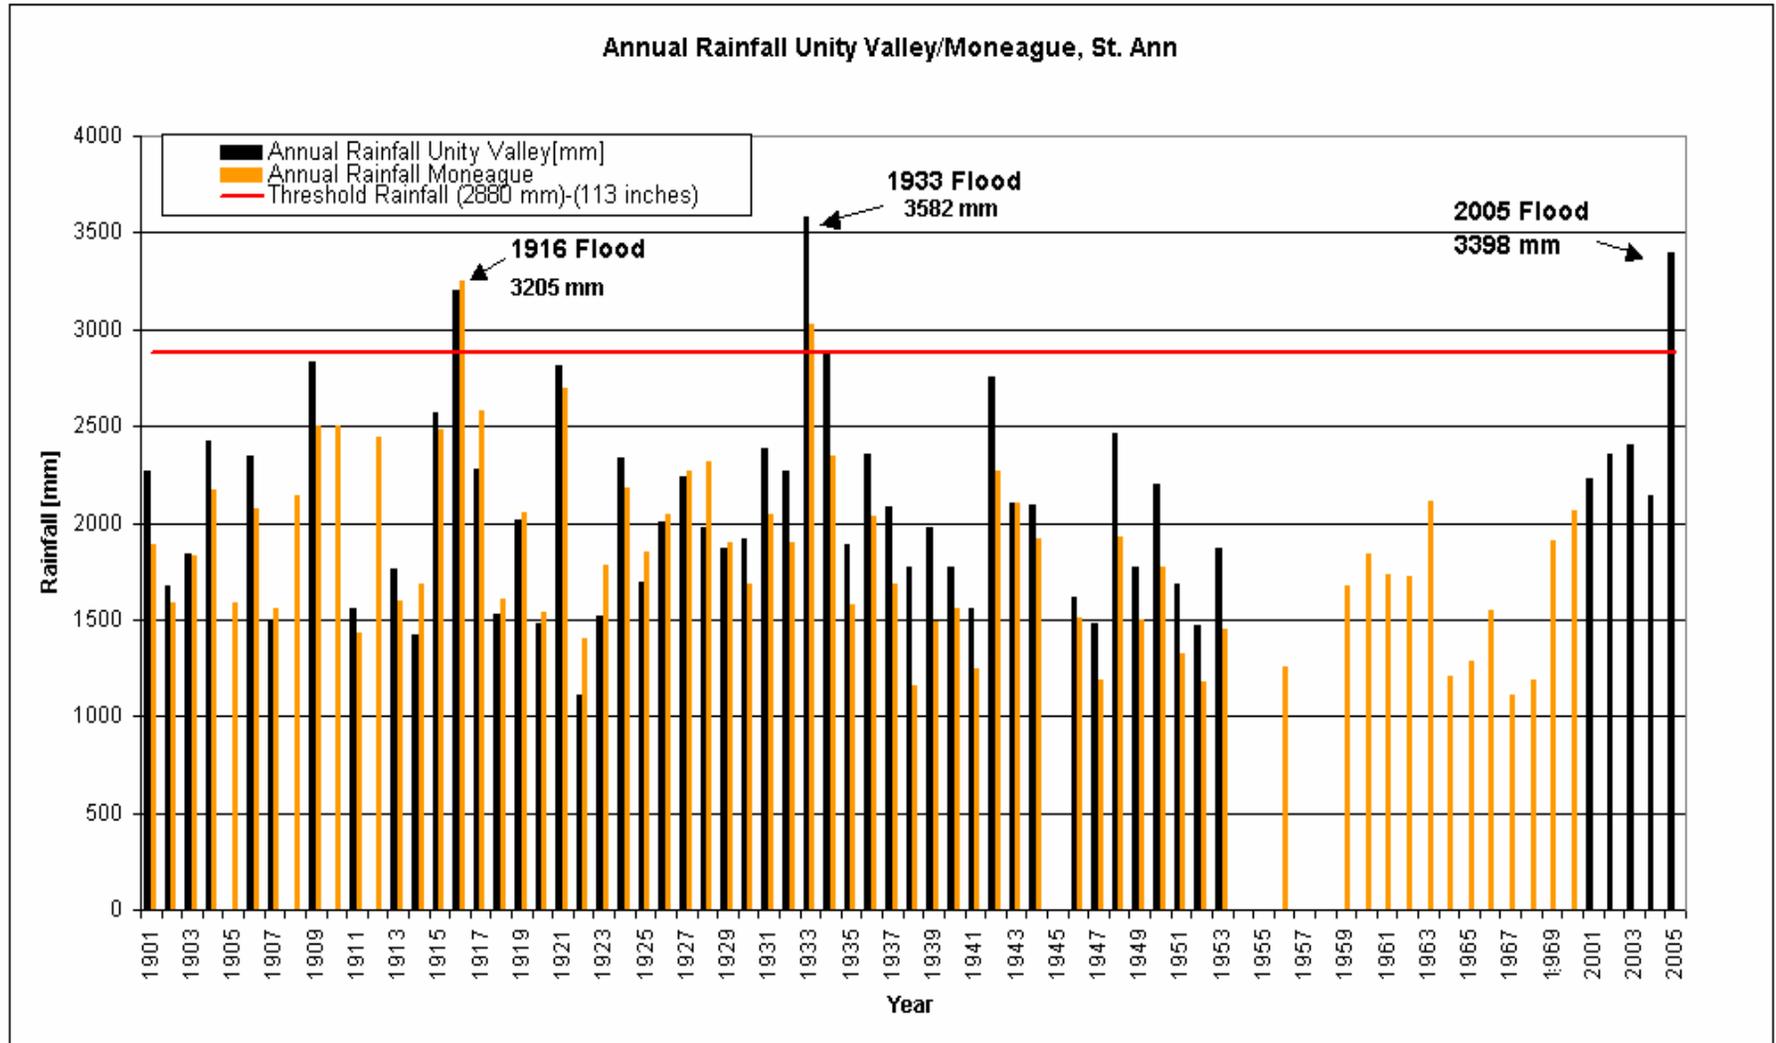
Antecedent Conditions

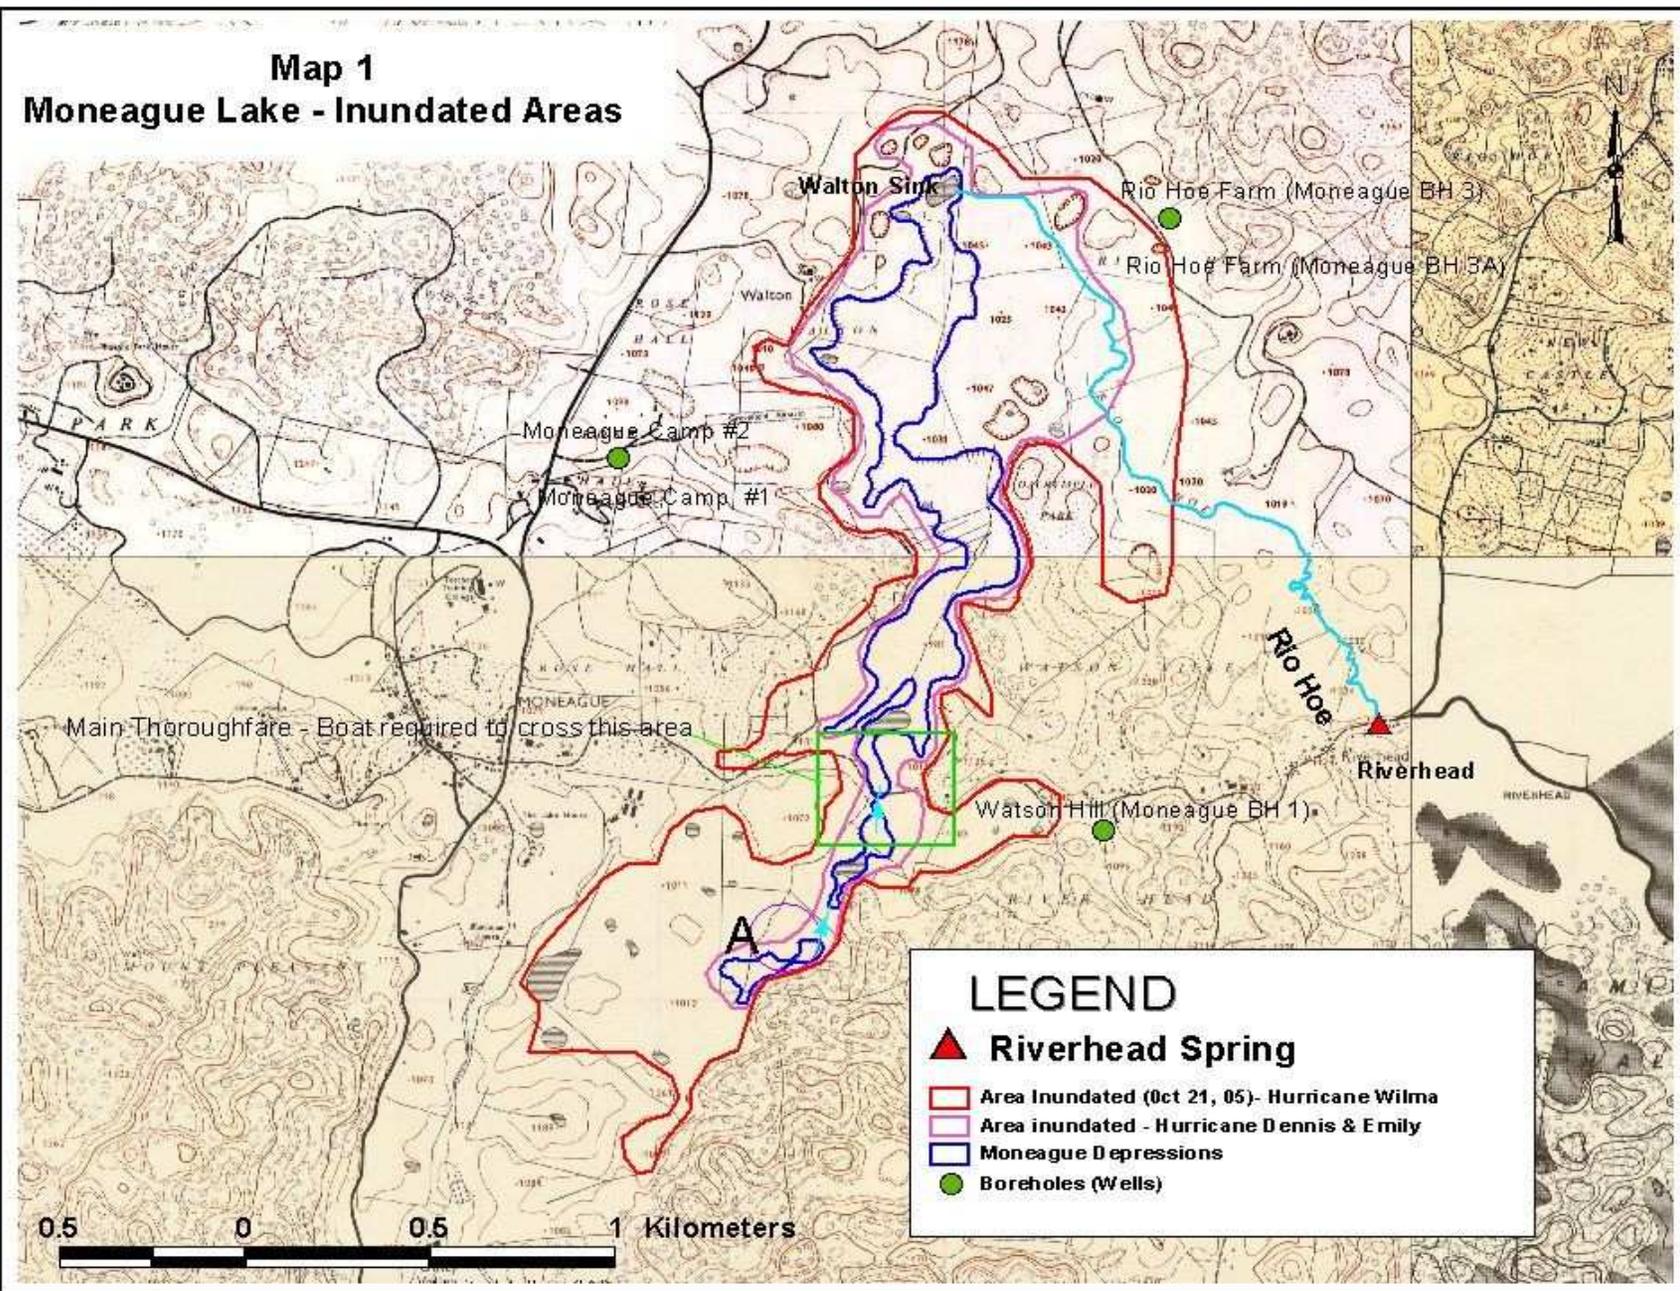
Present Flooding

Moneague Lake

- Area covered 1,680,859 m² (415 acres)
- Max depth – 12.5 m (41ft)
- Storage – 20 Mm³
- 12 house inundated
- Road flooded - limited access to communities
- Riverhead road depth – 7.5 m
- Rate of rise .01 ft /day
- Rate of decline-0.01 ft/day

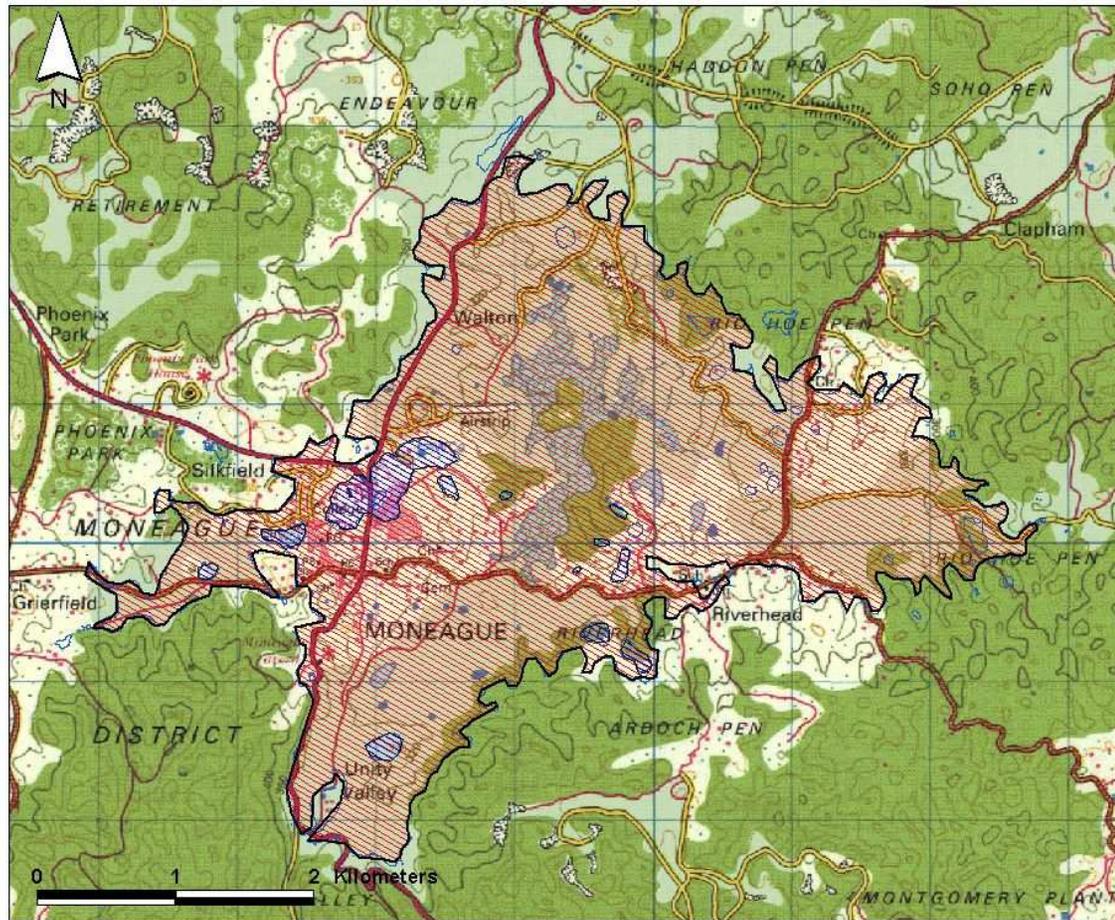
Moneague Lake approx. 3000 acres
